Inspection Report Minerals Regulatory Program

Mine	e Name: Snow White	Permit Number:	M/049/0030	Permi	t Fees:	Paid	
Ope	rator Name: Interstate Brick Co.	Inspection Date:	08/06/2013	Bond	Amount:	\$143,300.00	
Insp	ector(s): A. Abate, J. Hewitt, F. Delliskave	Time:	10:30 AM	Bond	Escalation:	01/31/16	
Othe	ers:	Mine Status:	Active				
Elements of Inspection					Comment	Enforcement	
1.	Permits, Revisions, Transfer, Bonds						
2.	Public Safety (shafts, adits, trash, signs, highwalls)						
3.	Protection of Drainages/Erosion Control						
4.	Deleterious Material						
5.	5. Roads (maintenance, surfacing, dust control, safety)						
6.	Reclamation				V		
7.	Backfilling/Grading (trenches, pits, roads, highwalls, shafts)			V	V		
8.	Soils						
9.	Revegetation						
					-

Mine: M/049/0030 Inspected: 08/06/2013

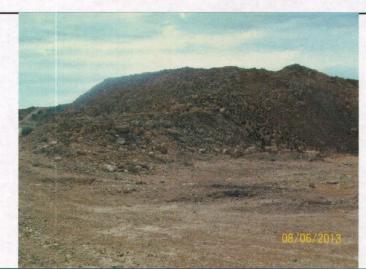
Closer view of the overburden stockpile.

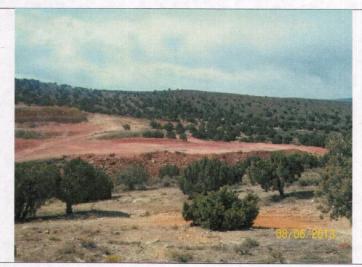
View of the south pit of the Snow White Mine. An ephemeral drainage cuts through as seen beyond the pinon/juniper trees. The flat area above represents an area where clay had been staged. This flat area should be reclaimed if no longer in use.

In accordance with R647-4-107.6,	The operator sho	uld amend their	plan to add the a	reas discussed	during today's	s inspection as are	as planned
for contemporaneous reclamation.	11011	/
